## INSPECTION REPORT

5277 Indianola Ave  
Columbus, OH 43214

John Doe  
OCTOBER 29, 2022

# 9: STRUCTURAL COMPONENTS AND BASEMENT

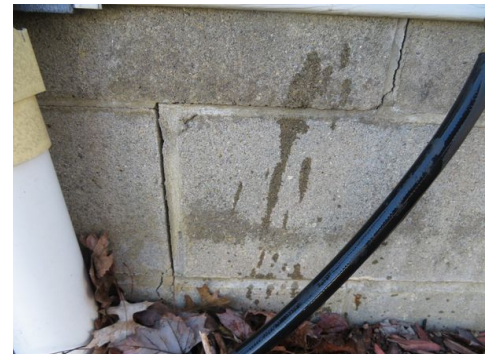
### 9.1.1 Foundation

#### SETTLEMENT CRACKS IN EXTERIOR FOUNDATION

There were a few settlement cracks in the foundation exterior. These were not considered structural. Recommend filling in with mortar to prevent water and insect infiltration.

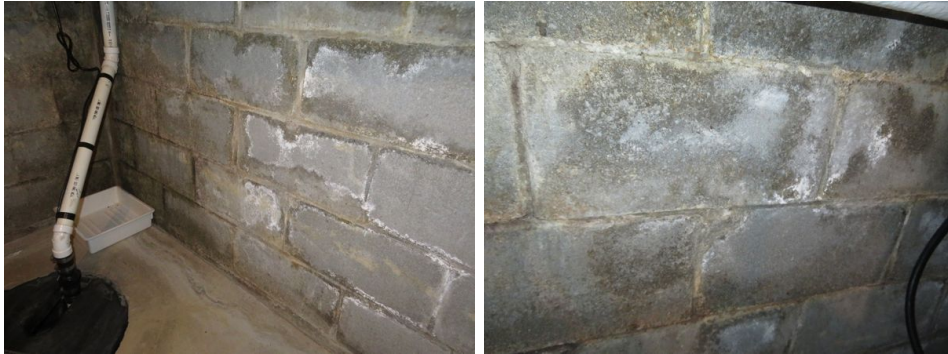
## 9.1.2 Foundation

**EFFLORESCENCE ON BASEMENT WALLS**

There was widespread efflorescence (white powder) on the basement walls near the sump pump and behind the washer. While the walls appeared dry at the time of the inspection, this indicates the walls were very wet at one time. Because the inspection is only one day, it is unknown if the walls will continue to be dry. Recommend monitoring for moisture and correcting all external downspout and grading issues that may be indicated in other parts of this report.

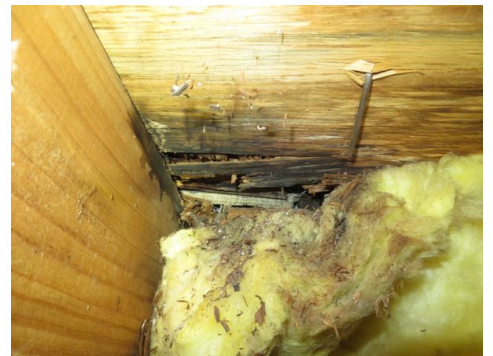
## 9.2.1 Crawlspace

**WATER DAMAGE IN CRAWLSPACE**

Water damage was found in the crawlspace under the sliding glass door. The area was dry at the time of the inspection. Recommend monitoring for moisture and repairing subfloor.

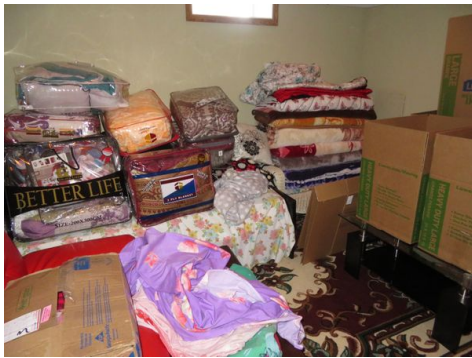
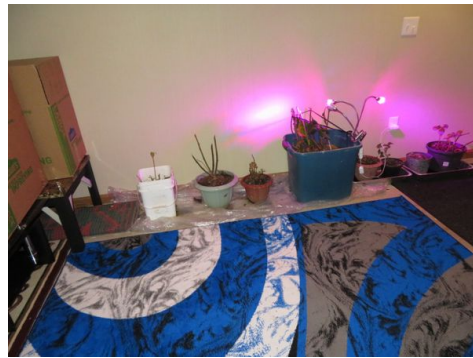
9.9.1 Structural Components and Basement Other

**BASEMENT NOT FULLY INSPECTED**

Not fully inspected – The finished basement was unable to be fully inspected because of stored items.
